Structural timber in 15th- and 16th-century town houses in 's-Hertogenbosch: Recent research on supporting structures

Maarten W. Enderman¹

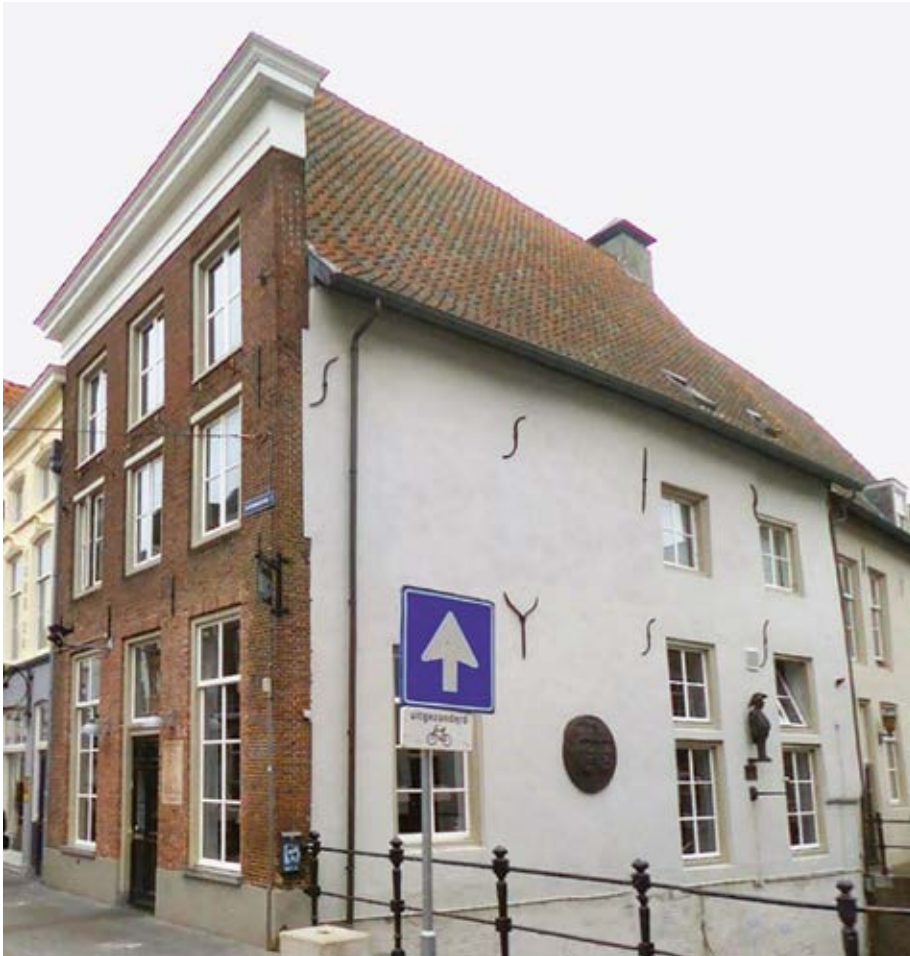
2.8

Fig. 2.8. The house 'De Drie Kroonen' at Korenbrugstraat 16 (1465d ± 4) with only a timber frame in the front part of the house, in which the upper floor and the attic may have been used for storage purposes.

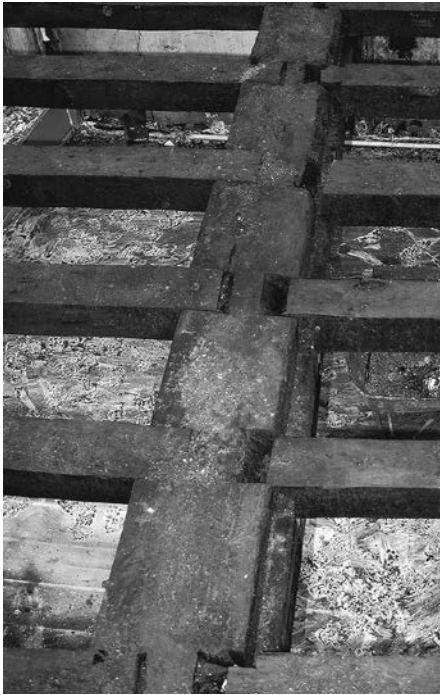
Fig. 2.9. Detail of the first floor structure in the front part of the house at Vughterstraat 122-124 (1566d ± 6) and drawing of notched joists with: a) no lip; b) recessed lip; c) dovetail lip; d) half dovetail lip; e) full dovetail. Image: courtesy of the Municipality of 's-Hertogenbosch SO/BAM; drawing: author

The simplest solution was to lay the joist ends on top of the crossbeam, where they were secured with a wooden peg. This method appears to have been abandoned after 1600. Notched joist joints can be sub-divided into those with and those without a lip (fig. 2.9a and 2.9b). The lip provided a surface through which the joist could be fastened to the crossbeam, which was partially cut away to receive the lip. After 1600 the lip dropped from use, a development that would appear to have started during the second half of the 16th century. From then on, the only means of supporting the joists consisted of a 1 to 2 cm deep notch cut into the side of the crossbeam.

In several cases where notched joists were used, some of the beams were given dovetail ends to create tension joints between two crossbeams or between a crossbeam and an end wall (fig. 9c, 9d and 9e). The limited research covering this phenomenon shows that dovetails were used only on oak joists, and that with a single exception the use of this type of joint was limited to compound floor structures that did not form part of a timber frame.¹¹ This type of joint was used from the 15th century to the end of the 17th century, but appears to have been most common in the 16th century.

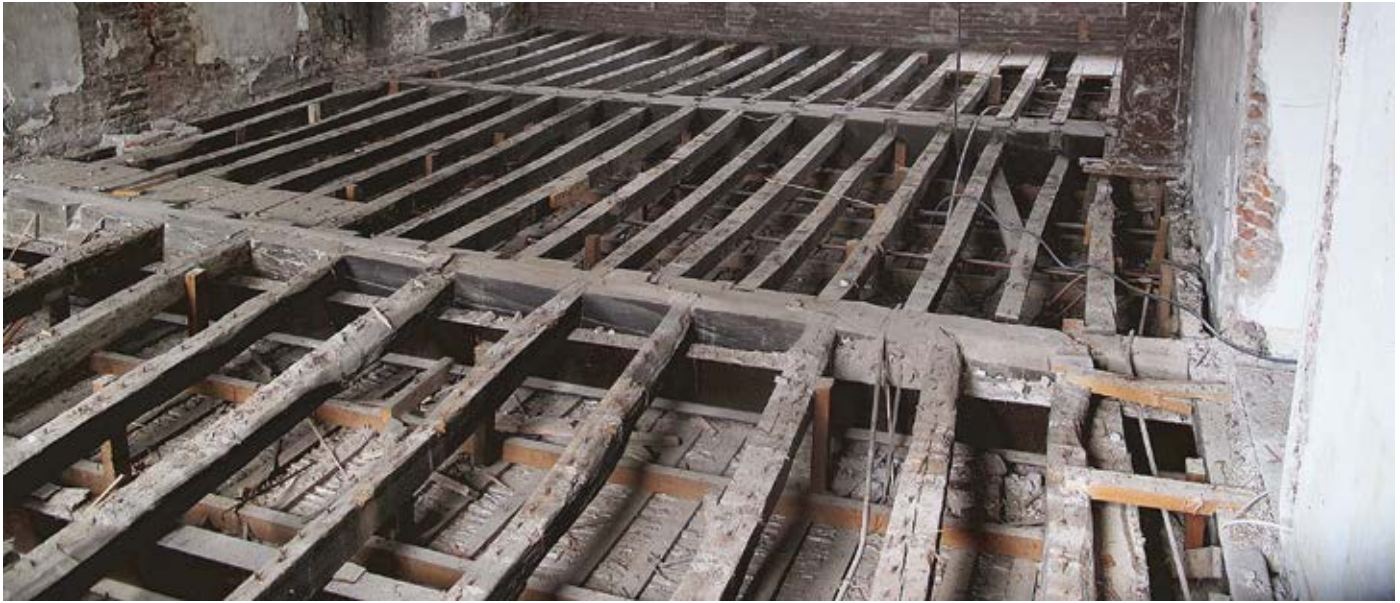
2.12

Fig. 2.12. View of the upper floor structure in the front part of the house at Kerkstraat 71 (1552d ± 2), looking towards the front. The section over the inside hearth contains fewer joists, and these are made of squared trunks. Image: courtesy of the Municipality of 's-Hertogenbosch SO/BAM

In the front part of the houses at Kerkstraat 71 and Vughterstraat 46 (1461d), the upper floor structures contain a combination of sawn and squared joists. In both houses the floor consists of three sections, the frontmost two of which use sawn timbers, while the rearmost section contains squared timbers (fig. 2.12). The difference stems from the sub-division of this part of the house into a front room and a separate back room (the 'inside hearth'). Unfortunately, it cannot be said that houses that do not show a similar use of different timbers did not feature an inside hearth. The absence of an inside hearth is confirmed for the house at Hinthamerstraat 184 and the houses at Hooge Steenweg 19 (1463d ± 6) and 21 (second half of the 15th century). However, the house at Hinthamerstraat 119, with its uniform upper floor structure, did originally feature a sub-divided front part. The reason for the partition may have been the presence of a partial floor over the inside hearth.

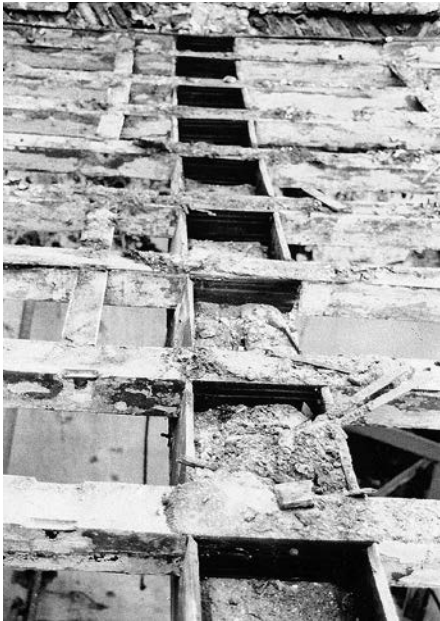
2.14

Fig. 2.14. Detail of the first floor structure in the rear part of the house at Orthenstraat 23-25 (1469d) and drawing of the layout, showing the use of filler boards to close the gaps above the crossbeam between the joists. Over the joists an ornamental ceiling panelling was laid with slats to cover the seams. Image: courtesy of the Municipality of 's-Hertogenbosch SO/BAM; drawing: author

- 13 The size of the filler boards is determined by the height and distance between the joists. The panels are approximately 0.5 to 1 cm thick and chamfered at the ends at the back to allow them to slide into the sawn grooves in the joists. It is known that wood was re-used for the boards, such as in the house at Kerkstraat 73 (fig. 1) where sawn drapery panels on the back side were found.

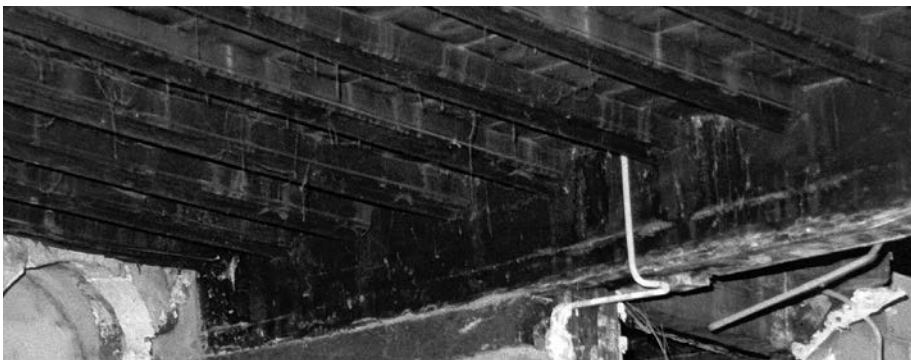
2.15

Fig. 2.15. Detail of the rare supporting structure above the formal room facing the street at the first floor of Hinthamerstraat 90, where the ceiling has decorative moulded joists. Image: courtesy of the Municipality of 's-Hertogenbosch SO/BAM; drawing: author

If exceptionally a chamber at the first floor in front of the house was present, then it was also a higher status room. For Hinthamerstraat 90 (1516d ± 6), it may have even been the best room in the house, because the supporting structure above it was made with joists elaborated with a fine profile (fig. 2.15). This is the sole example in ’s-Hertogenbosch of this kind of processing. Mostly in the front room only, the number of joists in the ceiling differs from the joists above the adjacent space which acted as a passage. At ground level the shop or workspace facing the street may show a similar status, not as high as the room to the rear but higher than the middle room known as the inside hearth. The inside hearth, as a kitchen, can be considered the least representative living space in the house. Often the squared trunk joists in the ceiling above it are darkened by smoke.
